## Watershed Protection Development Review

### 3.26 #30, WINGFIELD AND # 33, HARMON

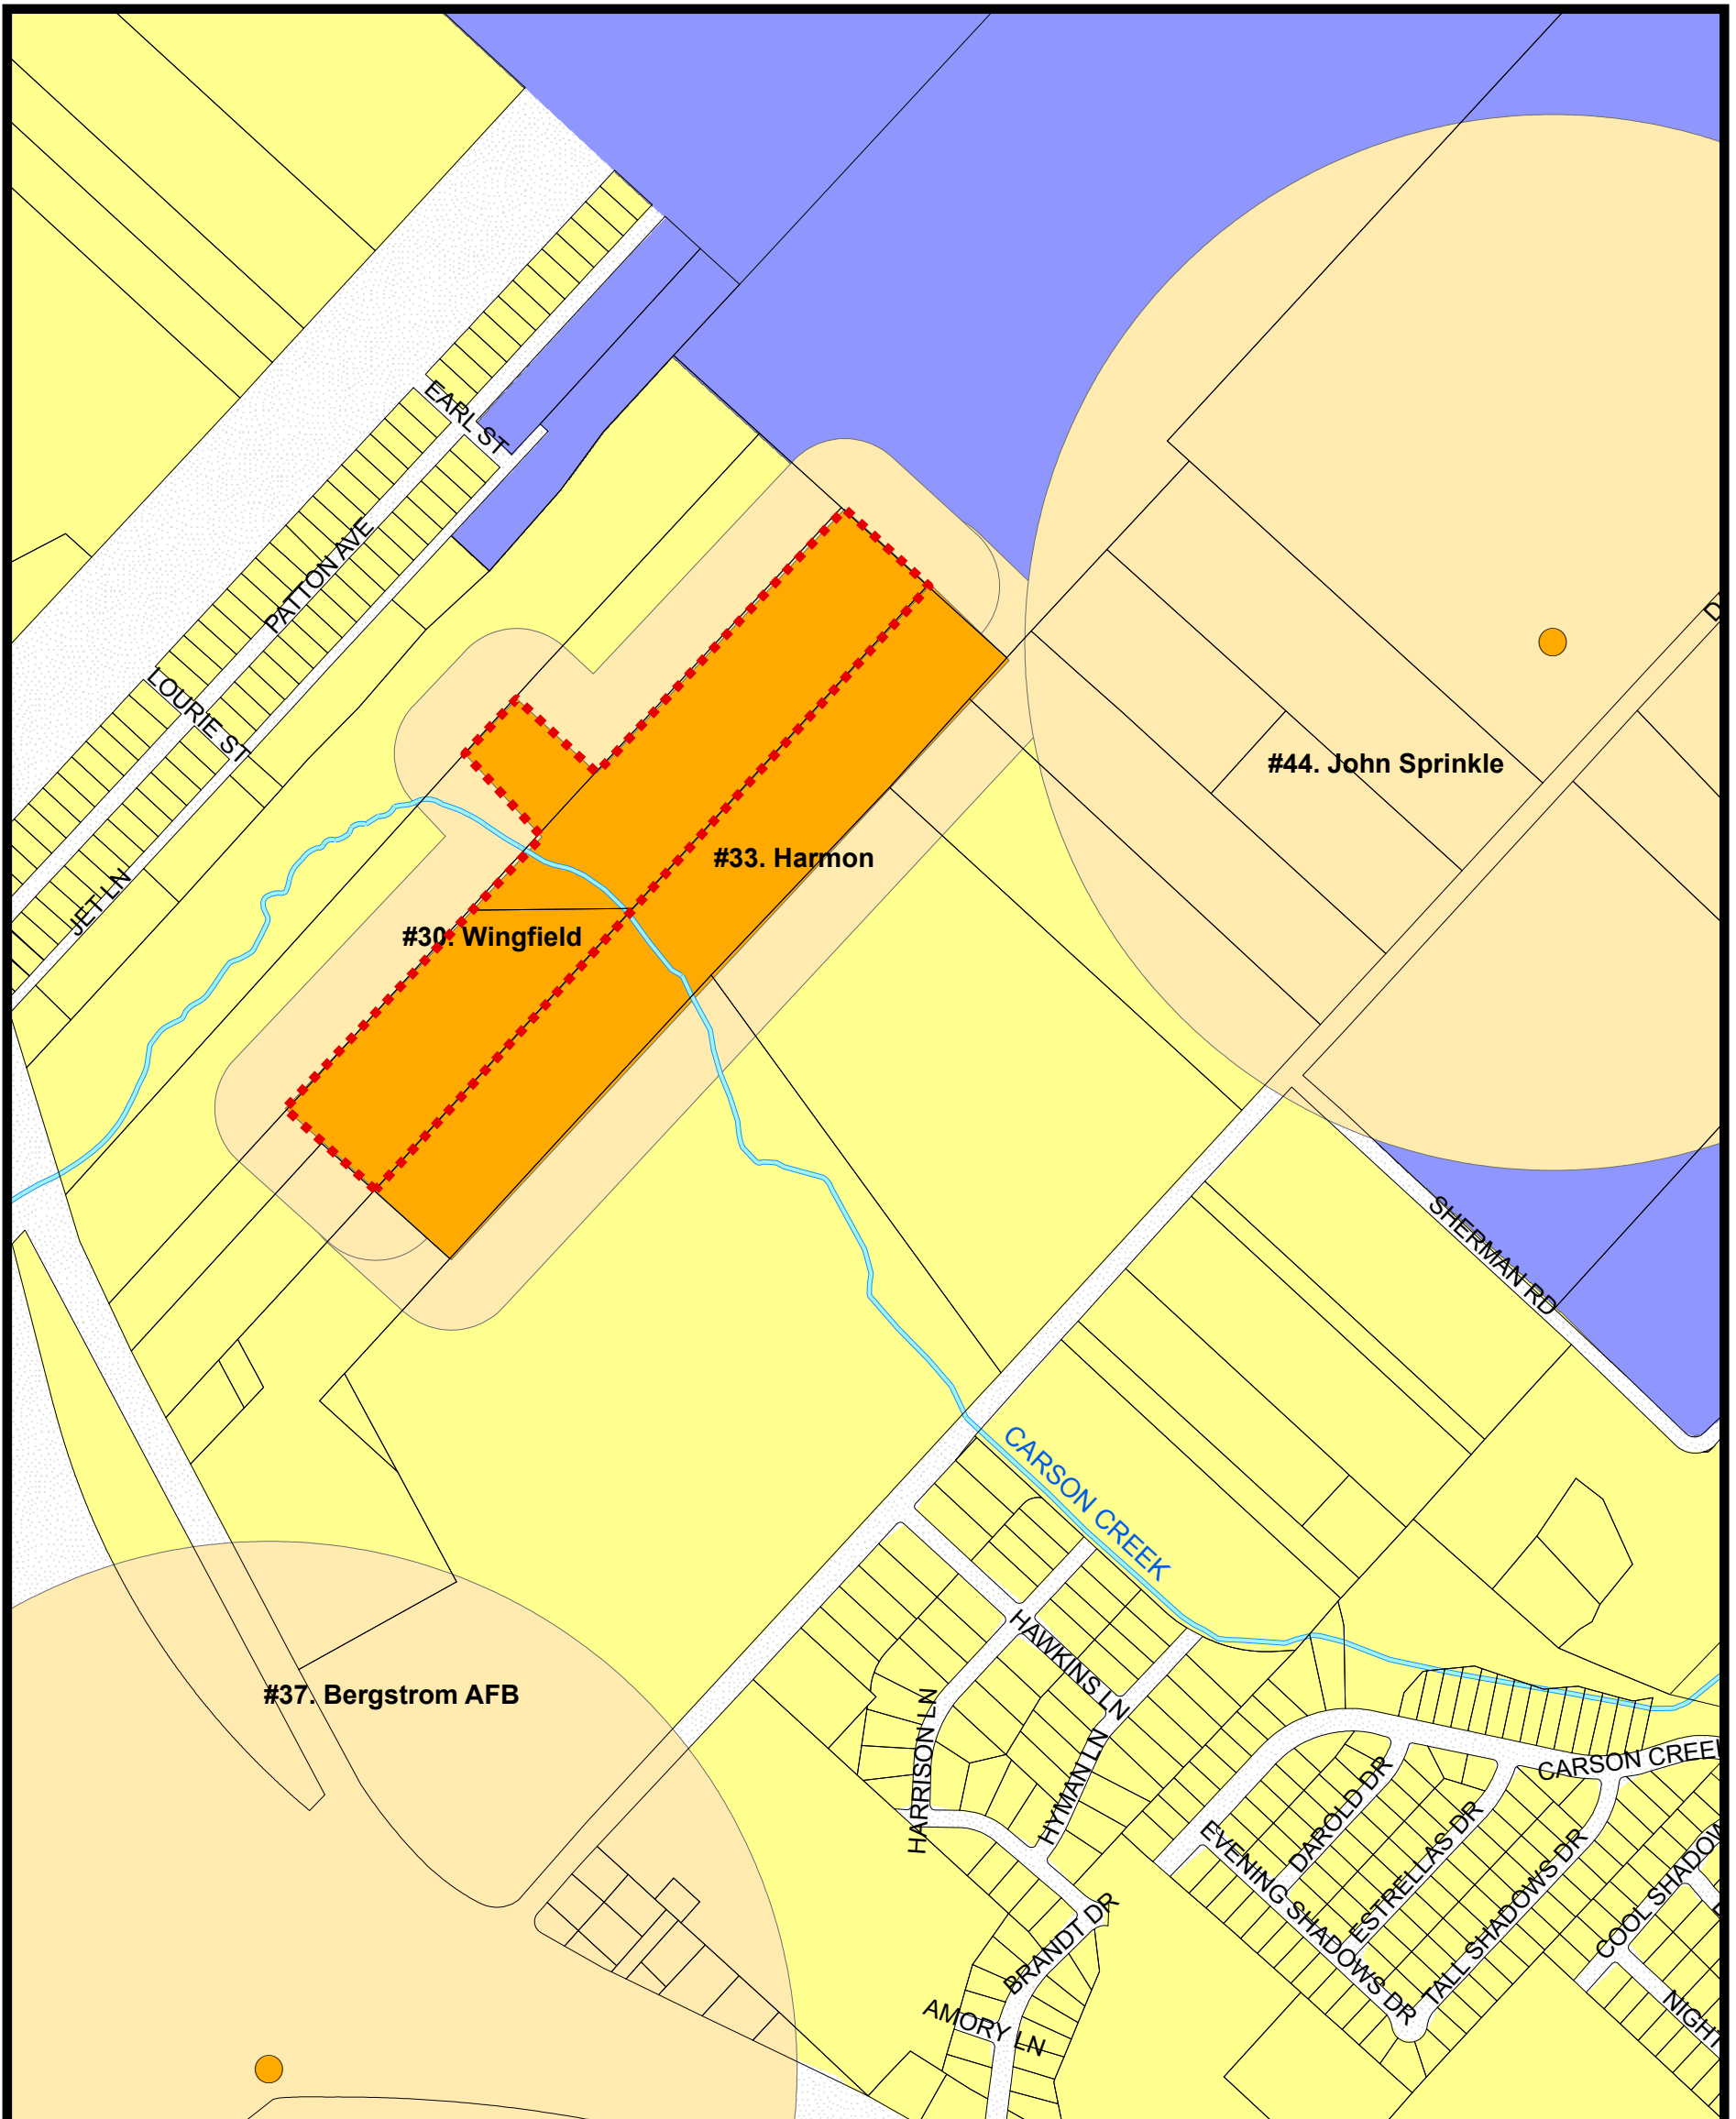
# #30. Wingfield

| <b>Landfill Features</b> | | <b>City of Austin Jurisdiction</b> | |
| | Estimated Landfill Boundary | | FULL |
| | Landfill | | LTD |
| | Landfill Buffer | | 2MIL |

**Location:** The Wingfield landfill and Harmon landfill are each owned by a private entity, and are located adjacent to each other in south Austin, just northeast of the interchange at Hwy 71 and Hwy 183. The Wingfield and Harmon landfills are landfills operated by different entities on two different (but abutting) tracts of land. It appears that both operations were placing waste in the same quarry that extended across both properties.
